Jefferson County Nearshore Restoration Feasibility Report

Prepared for:
Jefferson County Marine Resources Committee

Prepared by:
Coastal Geologic Services Inc.
Jim Johannessen, LEG, MS and
Jonathan Waggoner, BS

June 29, 2007

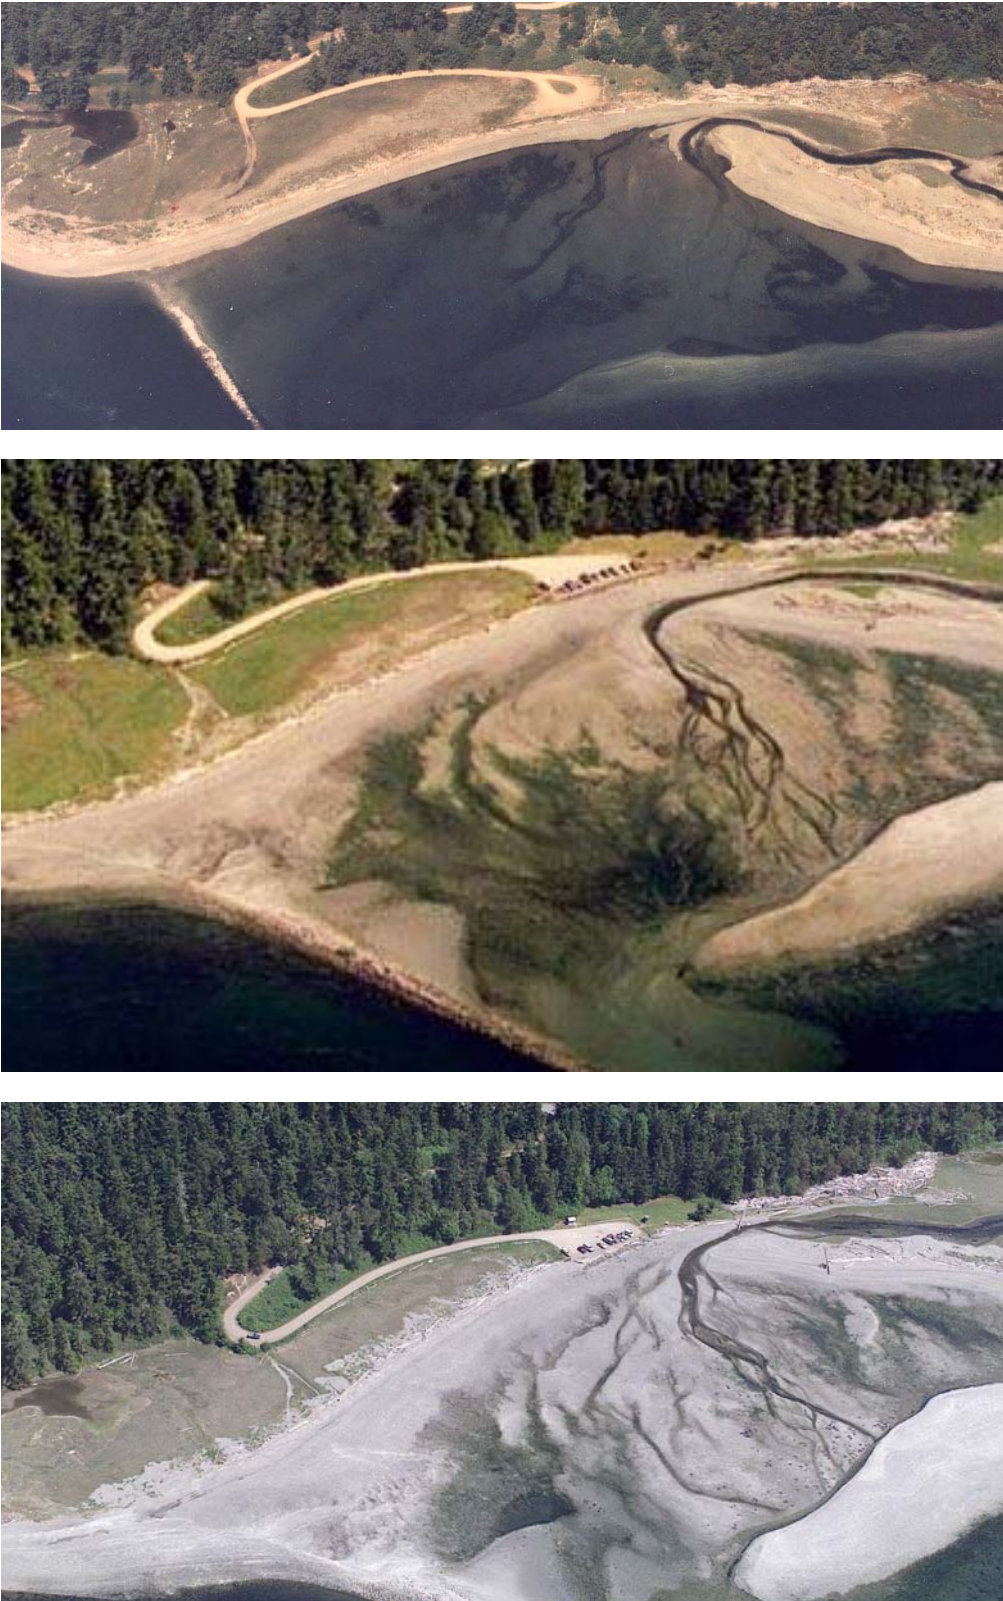
During the May 18 site visit the parking lot and many large (1-2 ft) rocks covered a portion of the intertidal beach (Figure 3). The intertidal at the park provides significant habitat functions and services as evidenced by the extensive use of the area for shellfish harvesting. Sand lance spawning was mapped at this site by WDFW. The beach is also at the mouth of the large, intact saltmarsh complex. The salt marsh drains through a tidal channel that runs immediately waterward of the parking lot at the site. In addition, the west boundary of the site abuts the Port Townsend Ship Canal and the large salt marsh at Oak Bay County Park, where juvenile salmon have been netted numerous times (Hirschi pers. comm.).

Figure 3. Oak Bay East oblique aerial photographs from 1977 (top), 1994 (middle), and 2001 (bottom). Note landward retreat of driftlog zone between 1994 and 2001.

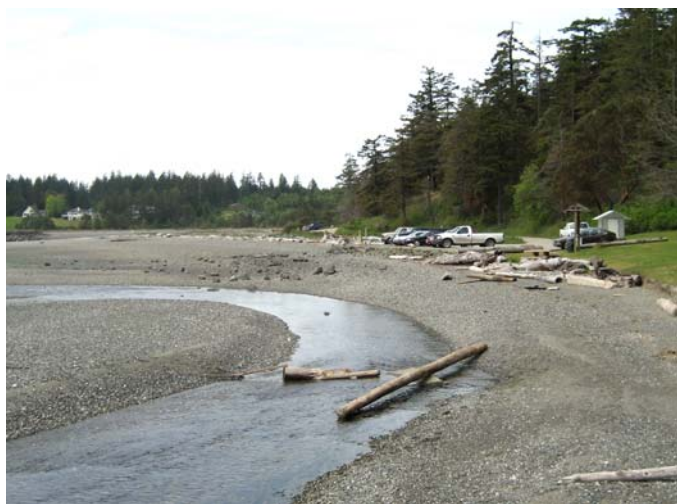
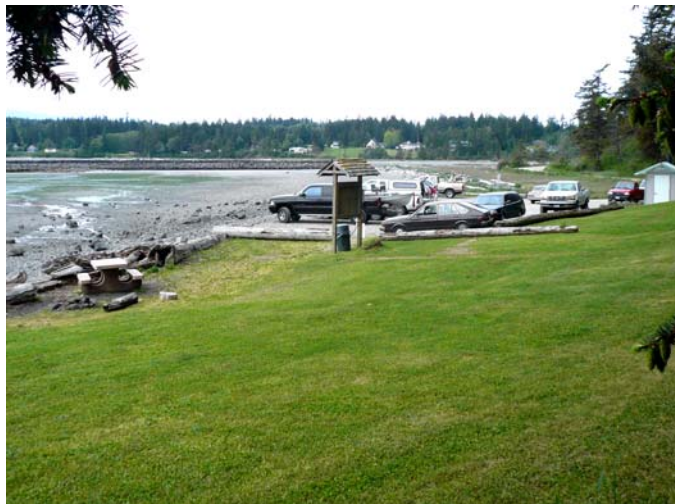
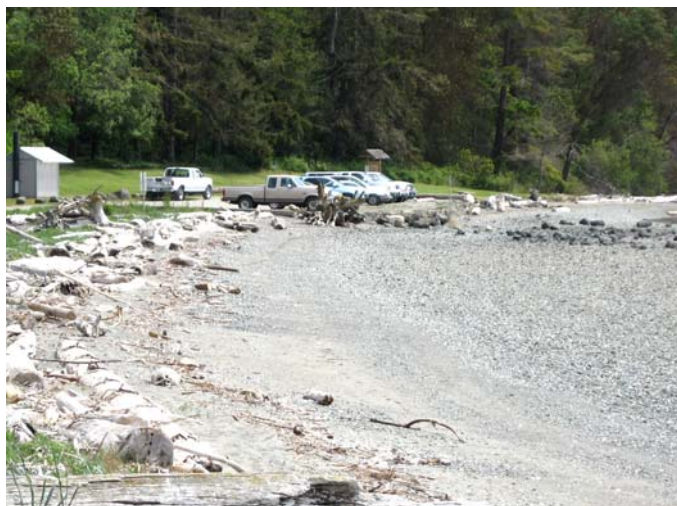
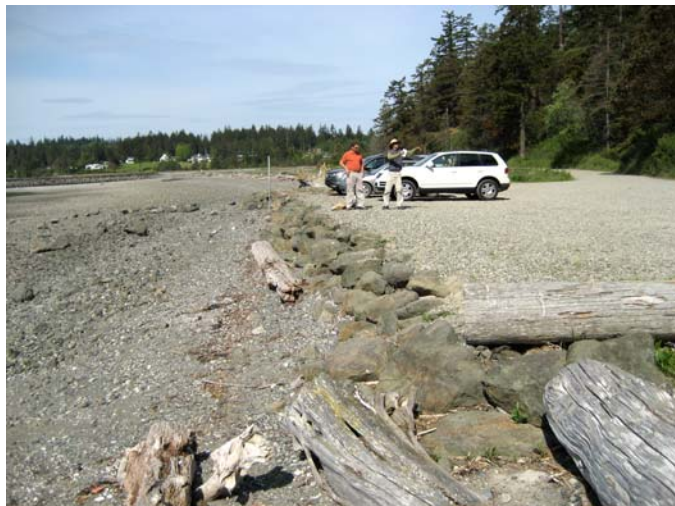
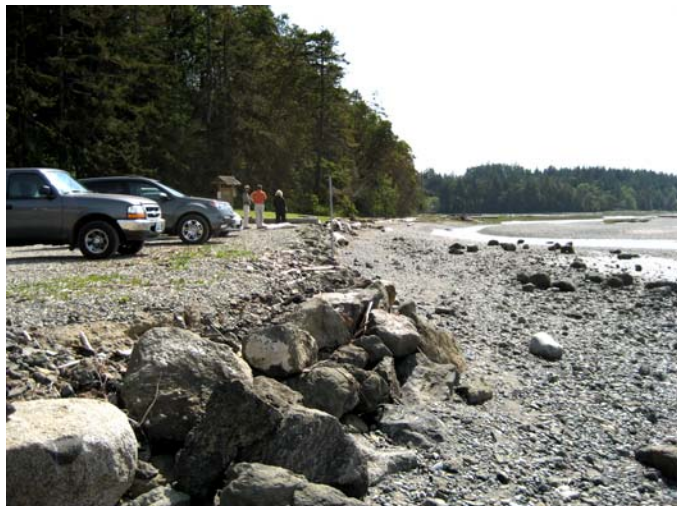
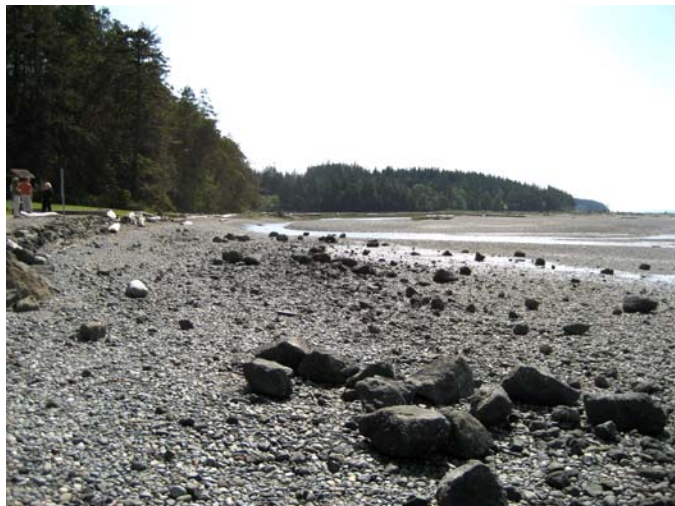
Figure 4. Oak Bay East ground photos taken May 18, 2007.

Impaired Conditions – Recent heavy winter storms have caused significant erosion to the waterward edge of the parking area. Matt Tyler, Parks Manager, stated that 8-10 ft of the parking lot was lost to erosion in the previous winter and drift logs were deposited on the access road and parking lot. Jefferson County Parks, in coordination with Randi Thurston of Washington Department of Fish and Wildlife (WDFW) recently reconstructed the rockery landward of its original position (Tyler pers. comm). Public access to the park is threatened by continued erosion of the parking lot. The site is a very important for public access for shellfishing and is also used environment education (Tyler pers. comm). The site does not have shellfishing access for handicapped persons. The Inter Agency for Committee for Outdoor Recreation (IAC) has informed the Parks Manager that this would be an ideal site for handicap access and that funding may be available.

The survey shows that the shoreline (measured at the log line) at the park lies landward of the waterward edge of the parking lot. The southwest edge of the parking lot is now on the order of 20 ft waterward of the log line (Figure 5). In addition, the Mean Higher High Water mark (MHHW) was at the base of the recently rebuilt rock revetment, indicating that waves are able to reach the rocks and parking lot daily.

Proposed restoration – To protect both the current, recreational use of the park and restore intertidal habitat through a simple manage retreat approach. This has been done before at this erosional area, as mentioned above. Specifically, it is recommended that the parking lot be moved landward on the order of 15-30 ft (Figure 6). The parking area should also be raised by approximately 2 ft vertical (to +14 ft MLLW) to prevent storm waves from overtopping the relocated rock revetment (Figure 7). The pit toilet, and possibly the access road, would need to be raised to match the elevation of the proposed parking lot. Some lowering of the grassy area within the footprint of the proposed parking lot would have to occur to provide a flat parking area. The logs that define the parking boundary will be reused for the same purpose in the relocated parking lot, as would the current park information sign.

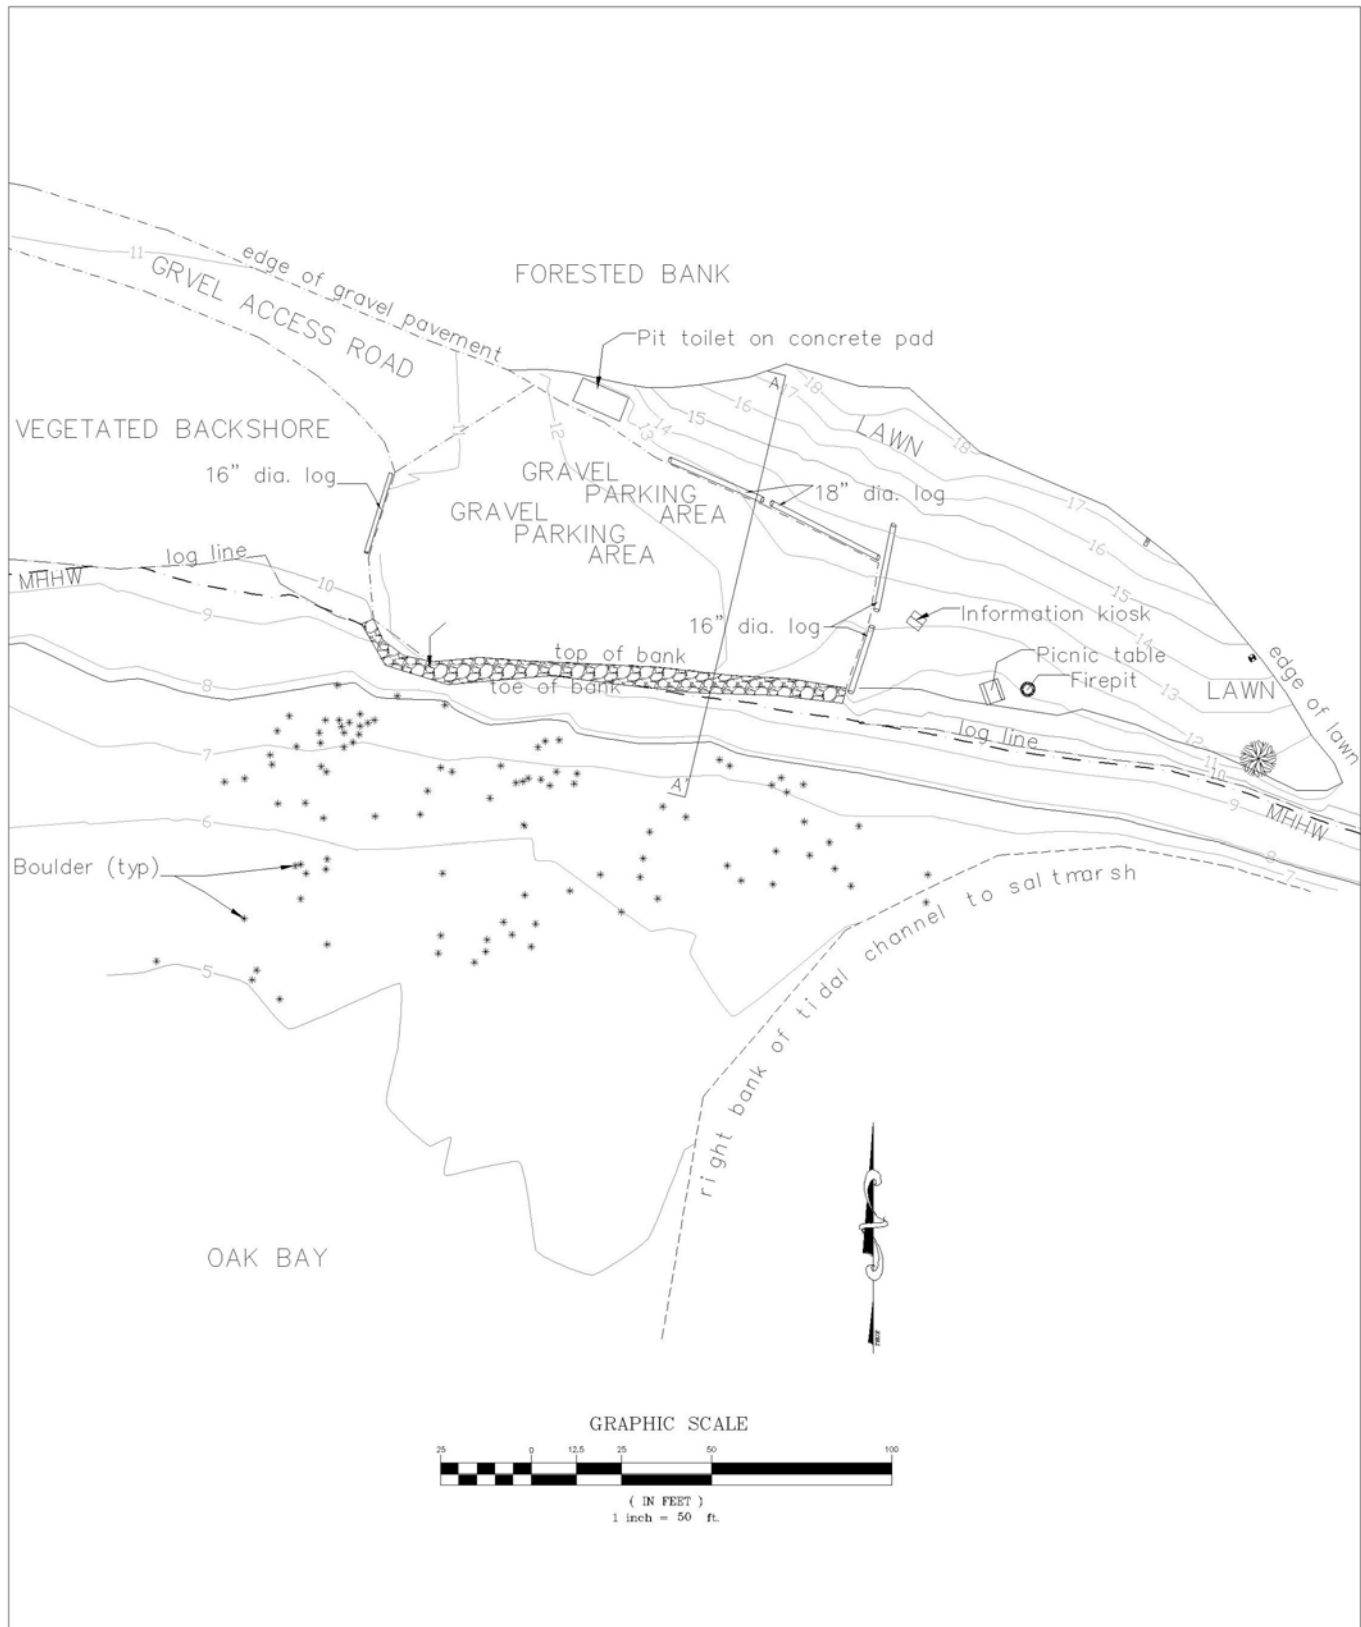
Figure 5. Oak Bay East existing conditions

The site was mapped using DGPS and a topographic survey using a high-quality total station with direct rod measurements on May 18, 2007 during a very low tide. An assumed grid was used to perform the survey, which was corrected afterward using DGPS coordinates. Elevation control was based on parking lot elevation in 2001 LiDAR data (Puget Sound LiDAR Consortium). The survey data were reduced in Autodesk Land Development Desktop where a topographic model was combined with GPS measurements to produce a site map (Figure 4). Individual shoreline and park features such as park improvements, rock wall location, waterward extent of driftwood (log line) were all noted and placed onto the map.

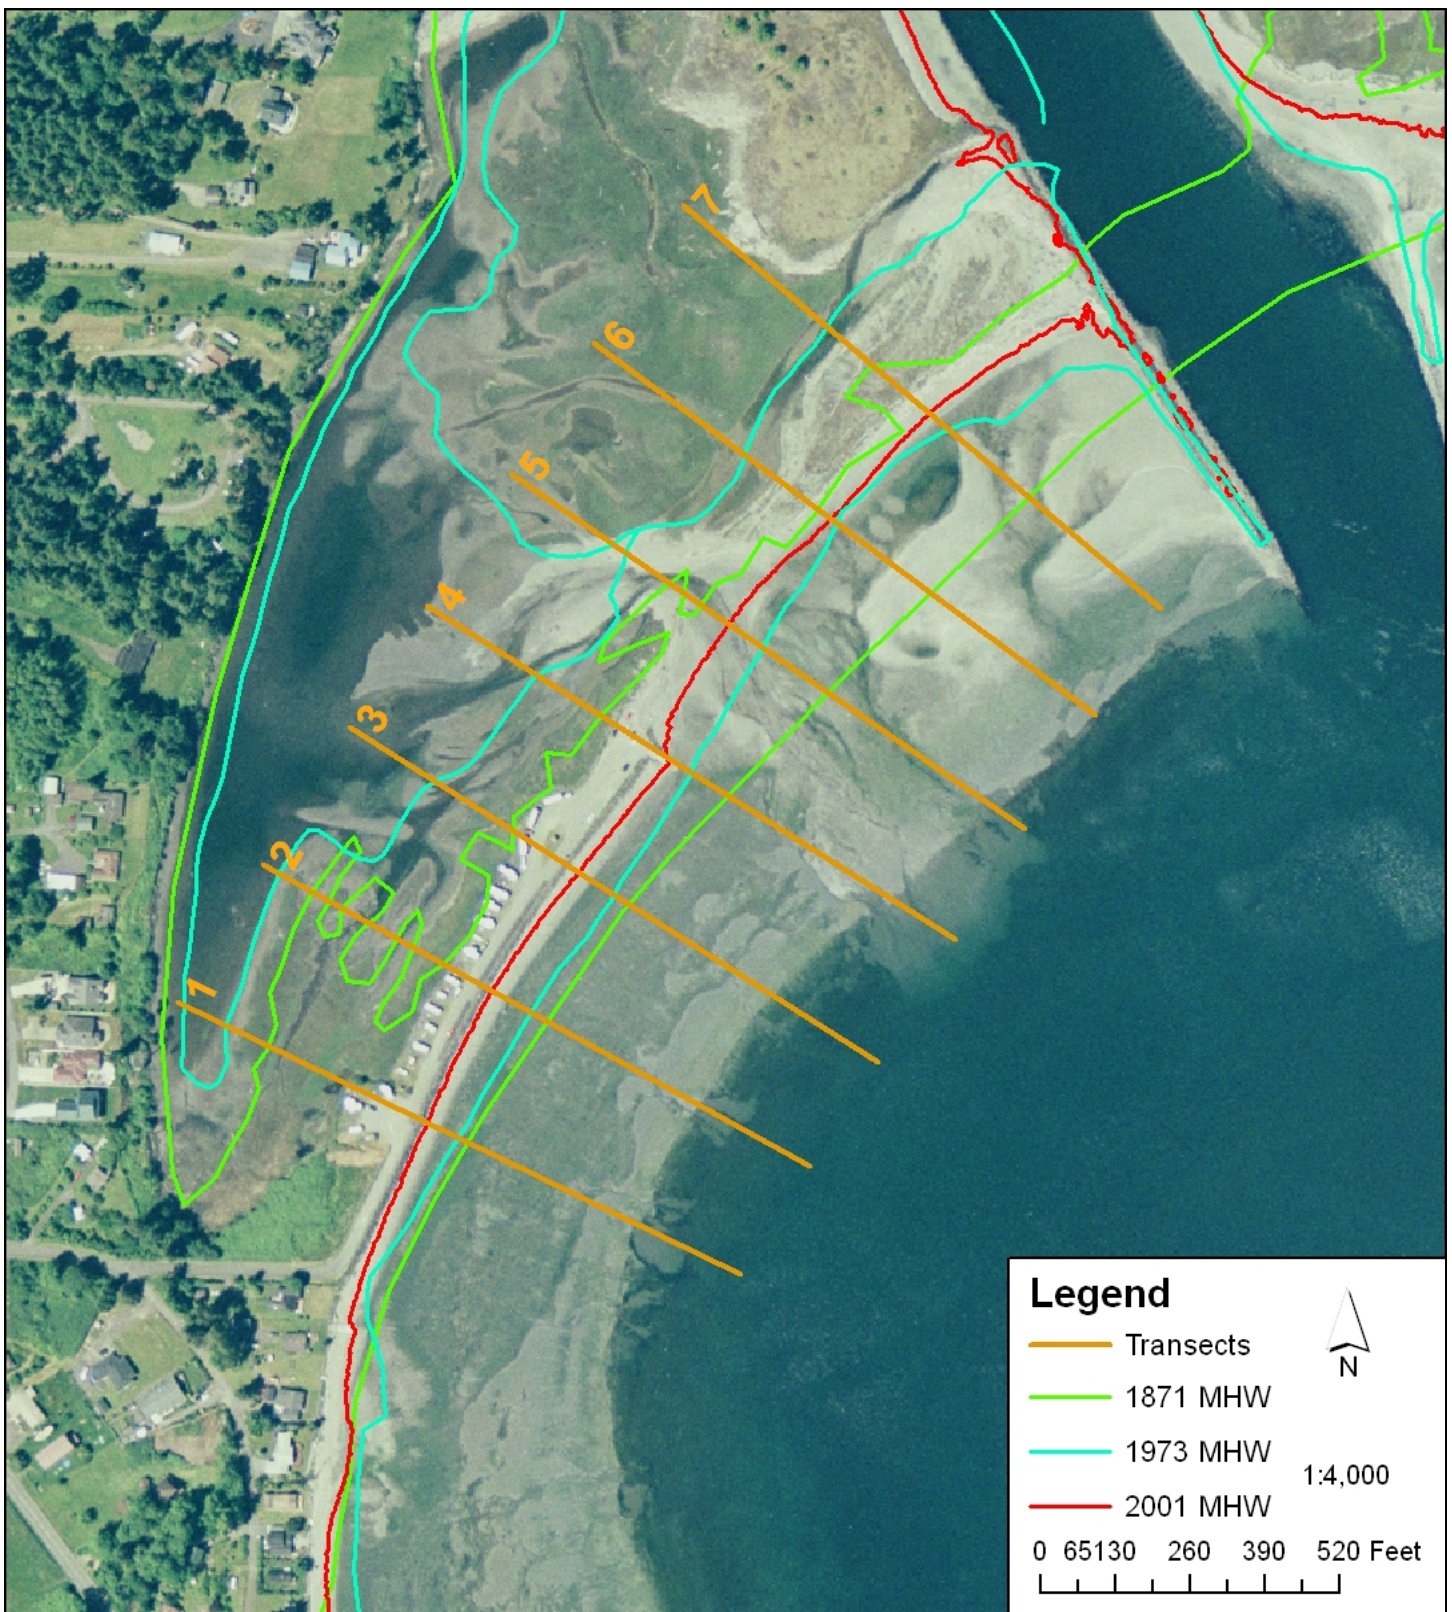
Figure 8. Oak Bay West historic shoreline change mapping

The waterward edge of the road has been armored with a rockery wall comprised of 2-3 ft rock (Figure 8). Approximately 25 ft landward of the park is a salt marsh complex that typically lies less than 50 ft from the camping sites.

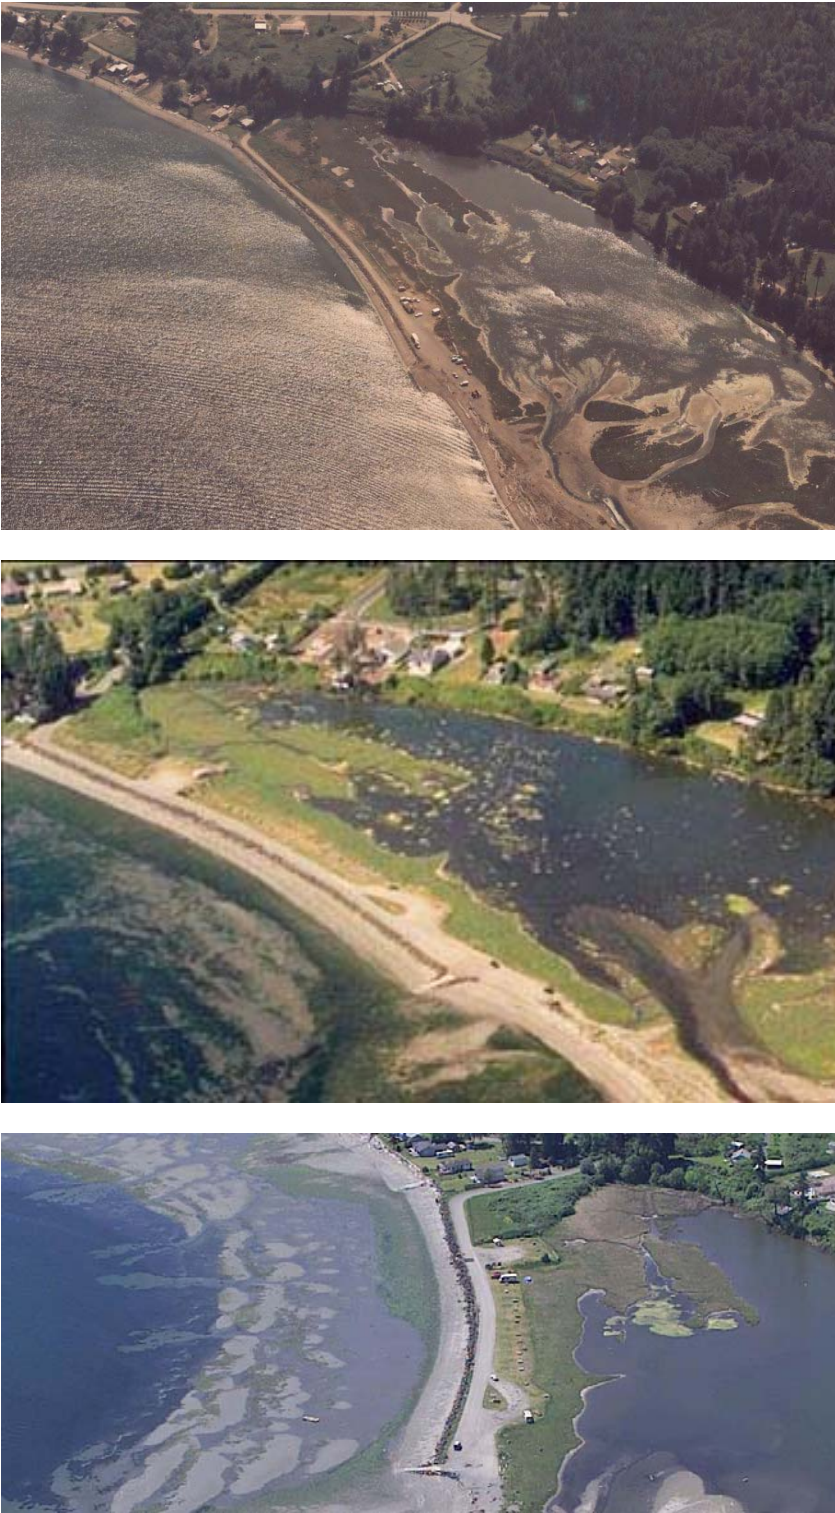
Figure 9. Oak Bay West oblique aerial photographs from 1977 (top), 1994 (middle), and 2001 (bottom).

The park road and portions of the camping sites were constructed atop intertidal habitat (Figure 9). During the site visit the upper intertidal sediments appeared to be of the type utilized as spawning substrate for forage fish such as sand lance and surf smelt, which typically spawn in the upper intertidal areas (Pentilla 1978). Sand lance spawning was mapped at this site by WDFW. Since the upper intertidal was covered by rock from the rock revetment waterward of the road, this beach likely no longer provides valuable habitat services.

Consortium. Erosion rates were measured for three shore-normal transects (Figure 9). The location of Mean High Water (MHW) for each of the above data sources was used to measure changes in the shoreline.

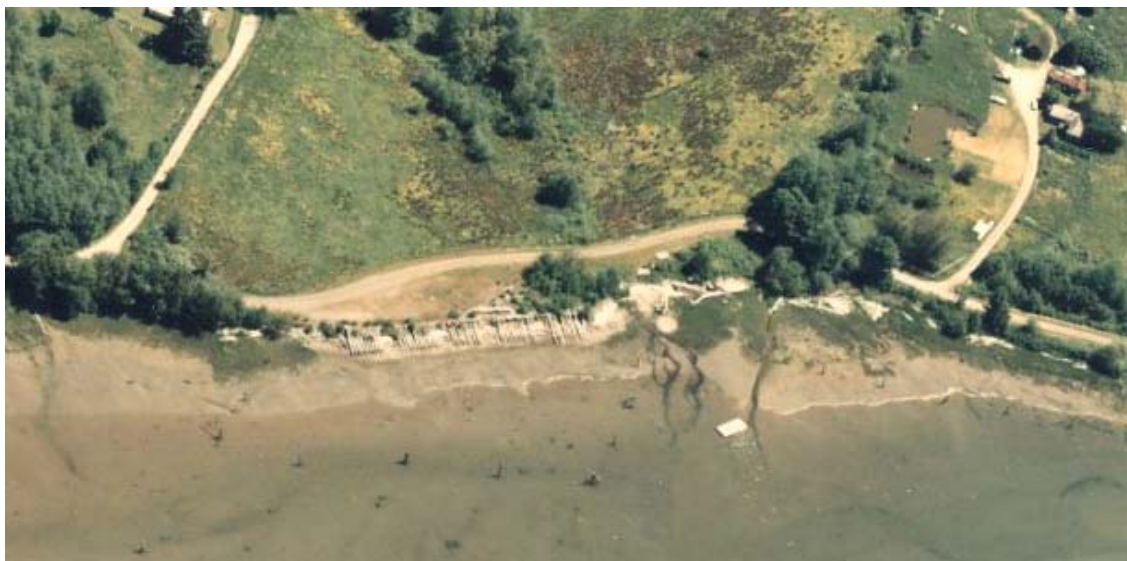
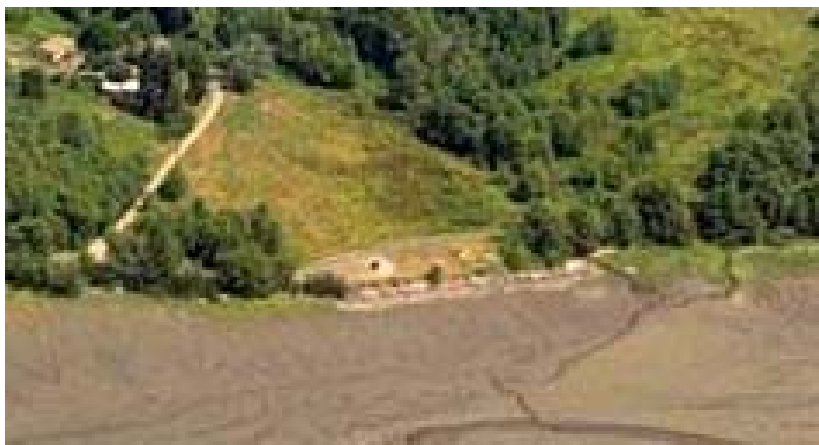
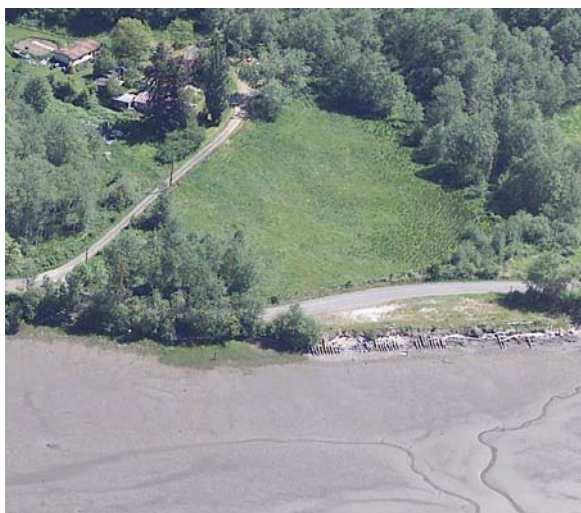
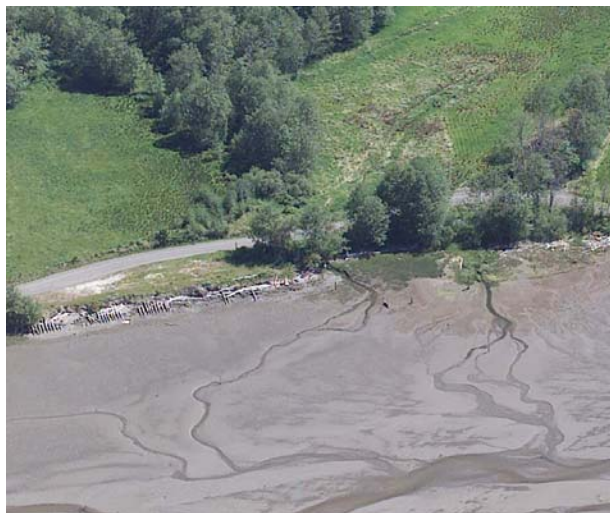
Figure 11. Tarboo Bay oblique aerial photographs from 1977 (top), 1994 (middle), and 2001 (bottom).

Location – The site is located in northeastern Tarboo Bay on the waterward side of Dabob Post Office Rd, approximately 250 ft south of the intersection with Broshear Rd. (Figure 1). This was the location of a log rolling operation, now abandoned in place with remnant rocks and logs on the intertidal. The logs have largely rotted away, but 25 upright logs remained at the time of the site visit (Figure 11).

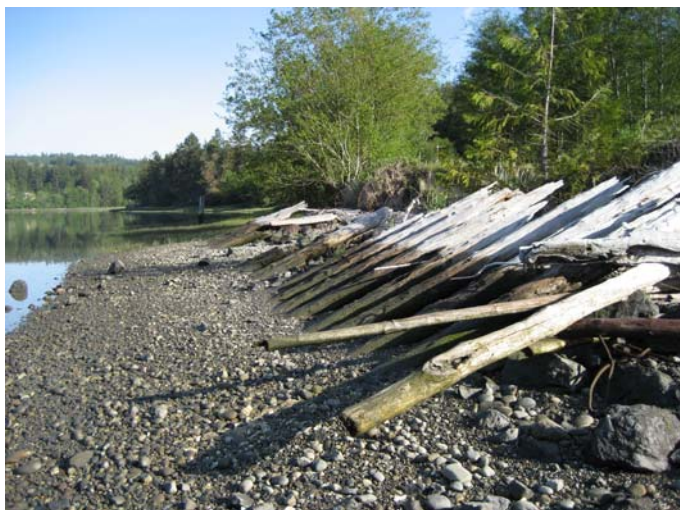
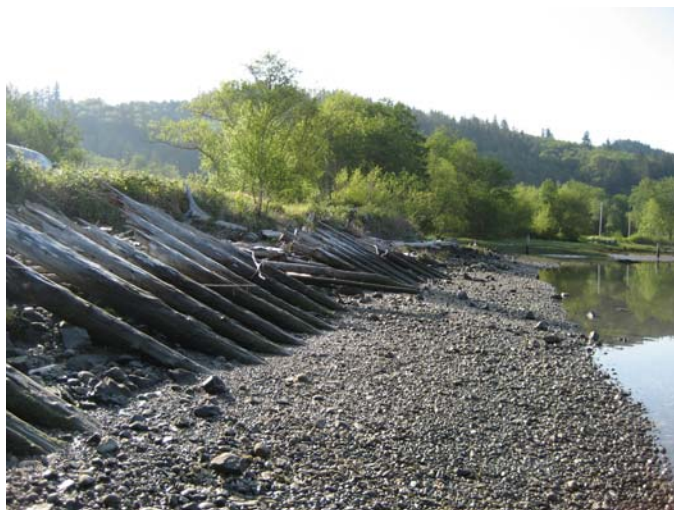
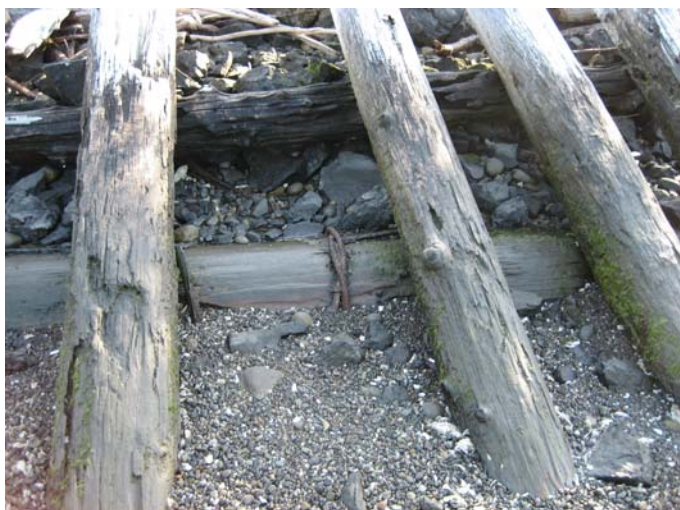
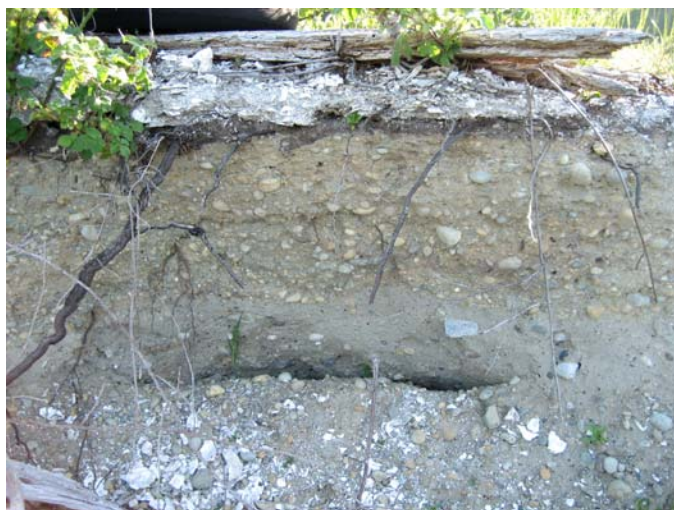
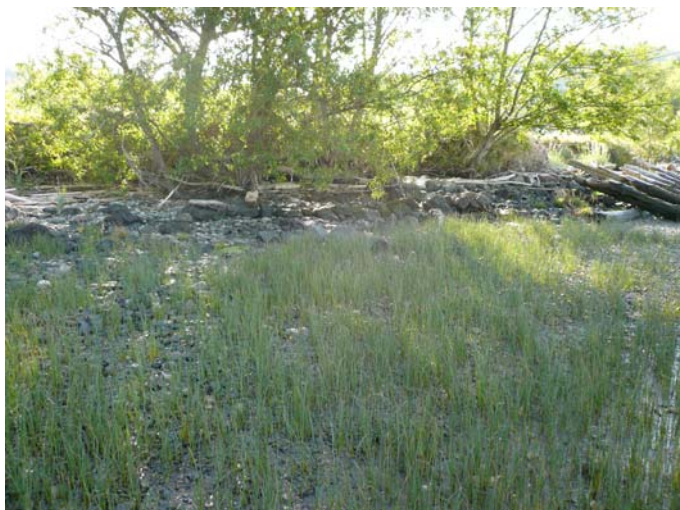
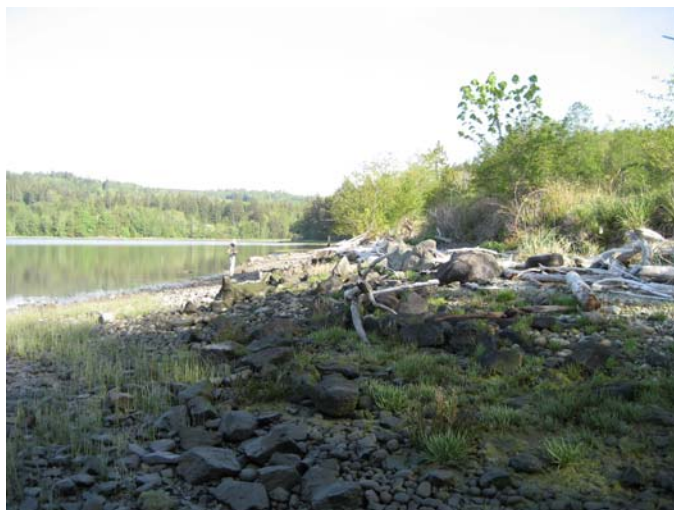
Figure 12. Tarboo Bay ground photos taken May 18, 2007.

Impaired Conditions – The upper intertidal area is largely covered by rock rip rap and logs (Figure 12). The rock consists of 2-3 ft pieces buried in the upper beach. Fronting the rock is several 20 in diameter, anchored logs laid out alongshore. In front of the horizontal logs are many closely-spaced logs sunk into the upper beach at a roughly 45 degree slope. These upright logs would have provided a ramp to roll logs into Tarboo Bay for transport to a nearby mill. Landward of the rock, in the area fronted by logs, was scattered smaller (12 in) rock

Landward of the rock and logs was an approximately 4 ft high bank comprised of compacted fill. Evidence of recent erosion was sign during the site visit (Figure 12). Atop the fill was a 2-3 in thick roadbed comprised of shell debris. The fill was likely deposited atop existing intertidal habitat during placement of the rock and logs.

Proposed restoration – Removal of logs and rock form the intertidal is the top priority at this site. Given the presence of creosote, special care must be taken in their removal to ensure proper containment and disposal offsite. An excavator with sufficient reach to remove the logs would be useful for removal, with a dump truck for transport off site. The horizontal logs appeared to be attached to an unknown anchor by ½ inch cable. These anchors should also be removed from the site.

After removal of rock and logs from the intertidal a moderate quantity of fill should be removed from the parking area to lower the slope, provide recreated intertidal and backshore area, and public better access as well as a transitional ecotone. Providing a 10:1 slope through the fill would require complete removal of the parking area. This may not be acceptable for the local users of the site. In order to provide increased habitat and preserve the current use of the property a slope bet 6:1 and 8:1 would provide habitat benefits. This would require removal of an approximately 25-35 ft wide stretch of the waterward side of the parking area. The upper portions of the slope should be planted with native dunegrass (*Elymus mollis*) to provide stability and additional habitat.

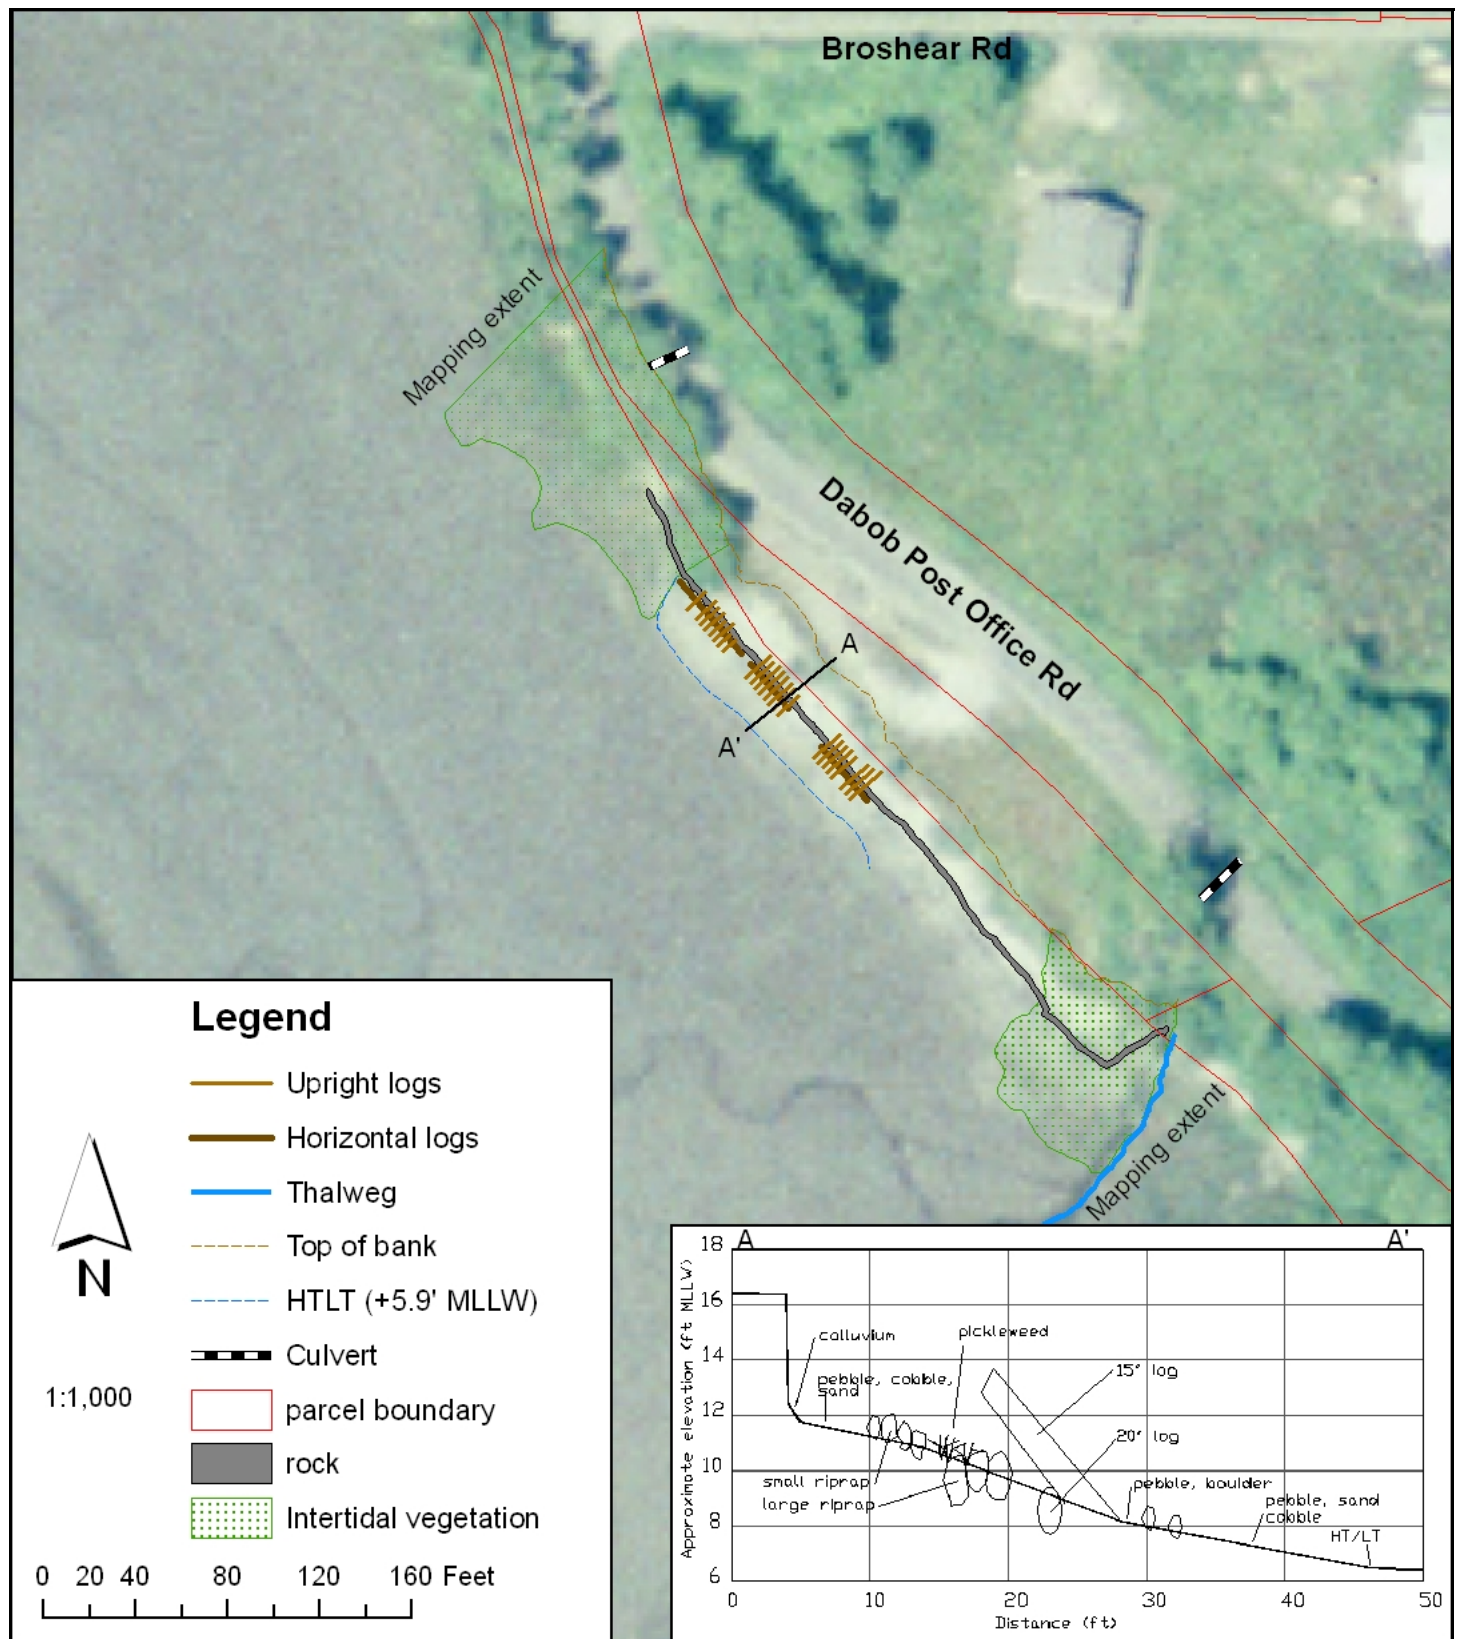
Figure 13. Tarboo Bay existing conditions

Mapping – Shoreline features at the site were mapped using DGPS. These features were all digitized and imported in a GIS for analysis (Figure 13). The line of rock was mapped as extending 350 ft alongshore, covering approximately 1,050 ft² of intertidal habitat. More habitat was covered by the smaller rip rap landward of the line of rock, but was not measured during the site visit. The remaining logs were in the central and northern portion of the site and cov a substantial amount of beach area.

A typical cross section was drawn from measurements made on site (Figure 13). Above and below the area of rock and logs the beach slope was found to be approximately 10:1 (H:V). Where the rock and logs were located the slope was approximately 6:1 (H:V).

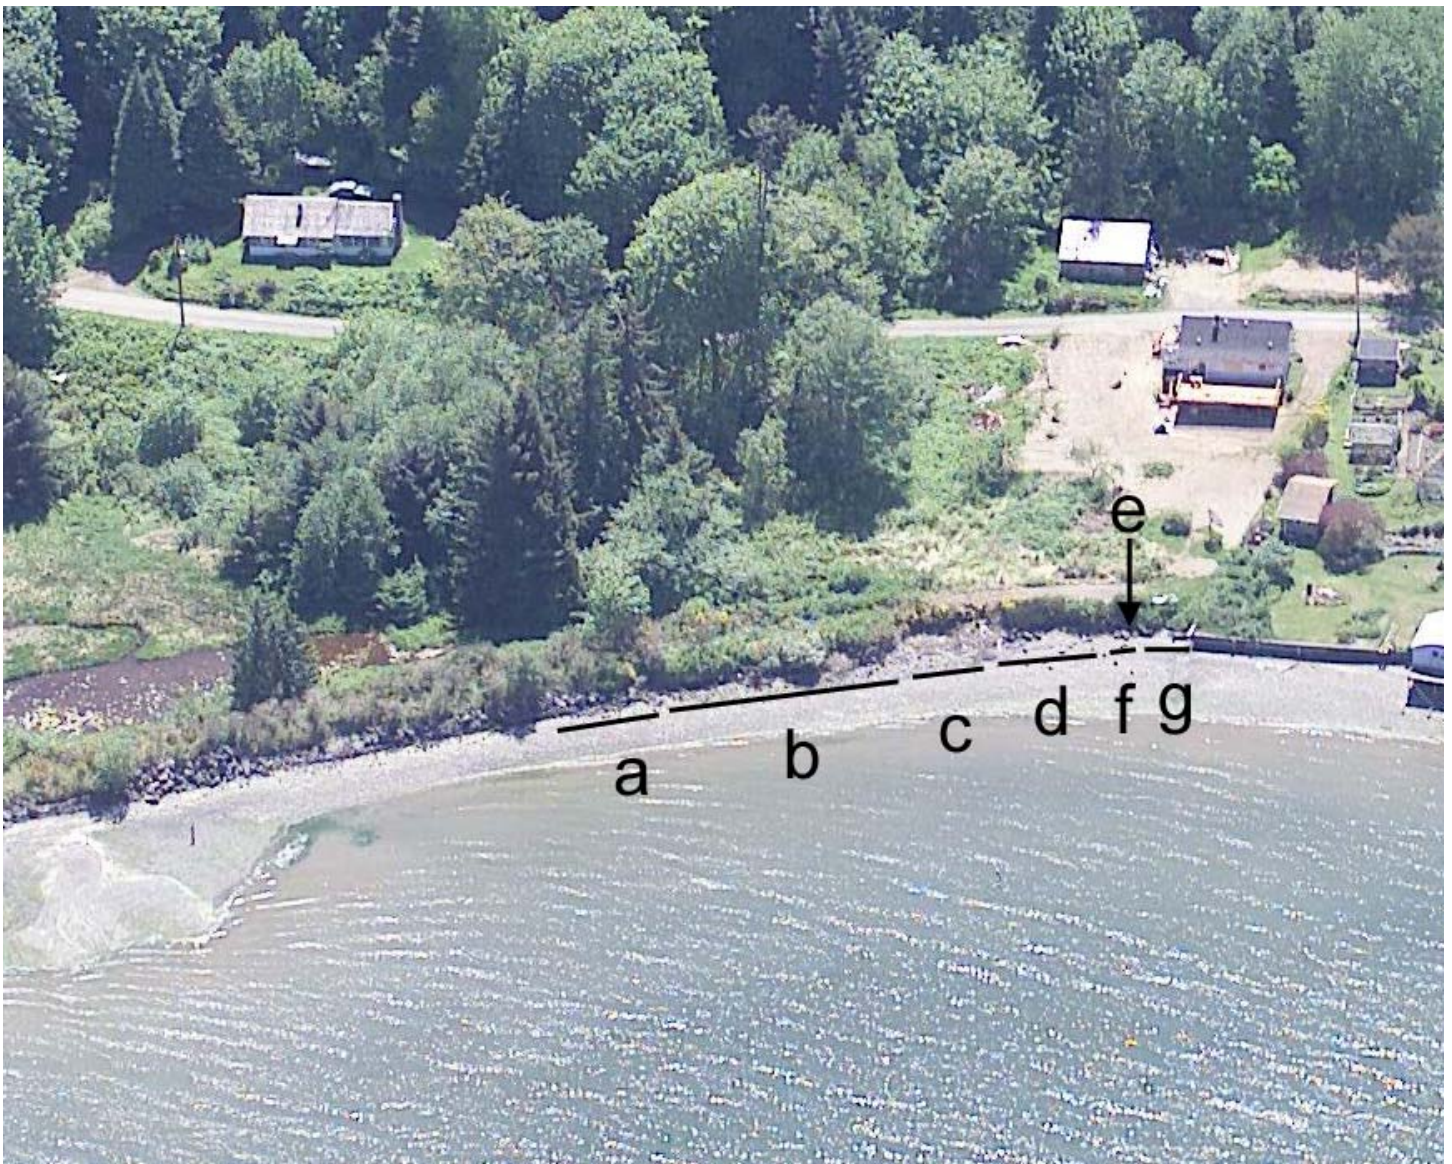
Figure 16. Fairmount Shore South existing conditions

Table 1. Potential rock removal area from upper beach at Fairmount South Shore by shore segment (Figure 16).

Shore Segment	Length (ft)	Width (ft)	Area (ft ²)	Description
a	33	5	165	tight, large & small rock, stacked
b	59	4	236	tight, large & small rock, stacked
c	16	3	48	tight, large & small rock, stacked
d	29	4	116	scattered, large & small rock, stacked
e	15	5.5	82.5	large, tight rock
f	8	2	16	scattered rock
g	4	3	12	scattered rock
Total	164		675.5
